**General Inspection Report One: A general inspection
into metal roof construction in Western Australia**

April 2016

BUILDING COMMISSION GENERAL INSPECTION REPORT ONE (GIR1)

ROOF CONSTRUCTION: A general inspection report into the construction of sheet metal clad timber framed roofing in Perth metropolitan and South West regions

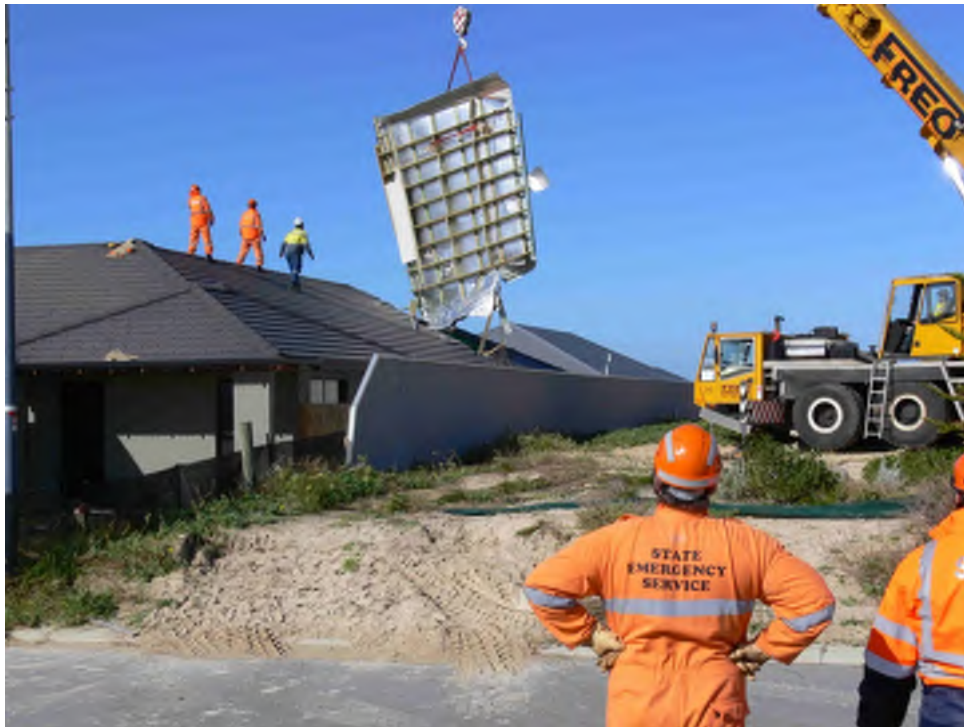
Although a skillion roof is not necessarily representative of the majority of conventional roof framing found and analysed in this general inspection this event indicates both a failure to construct correctly and not supervise adequately. The result of this type of failure is a community concern with risk consequences beyond the failure of the specific roof system involved.

Figure 7. Photograph showing the result of a metal skillion roof lifting in high winds and landing on and damaging an adjoining property

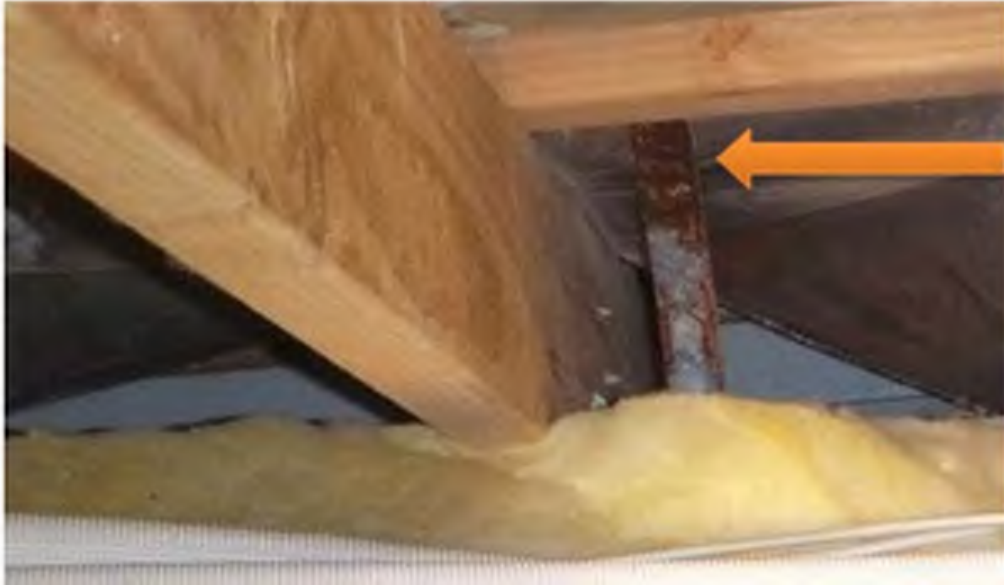
A dwelling (Figure 8) inspected in connection with a building service complaint was found to have severely corroded roof tie-down straps, only 4 years after installation. The degree of corrosion is consistent with the use of non-compliant tie-down straps for buildings within 0–1 km distance of a coastline with breaking surf and may lead to premature failure of the roof/roof components.²¹

Figure 8. Photograph showing the result of installing a strap without the correct corrosion protection

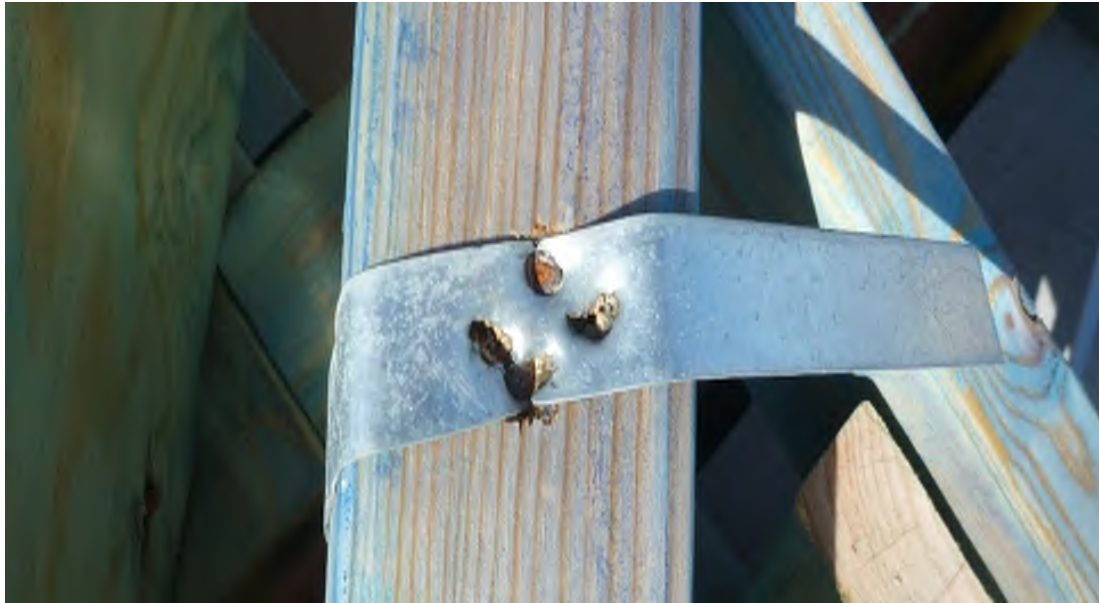
- Figure 9 below demonstrates a typical example of the type of damage to the tie-down strap roof connection observed during the general inspection).

Figure 9. Photograph showing a metal tie-down strap fixed to a batten via the use of machine driven nails. The over-driving of nails has damaged the strap, greatly reducing the connection capacity.

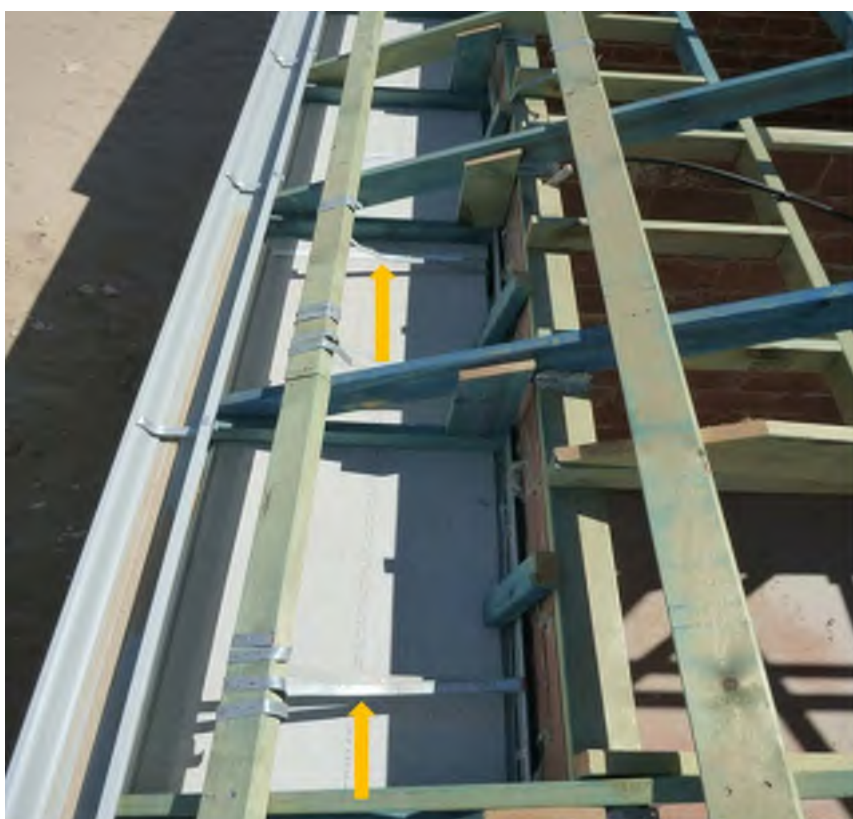
- The use of specific battens for top fixing tie-down straps, has its benefits. Tie-down battens of this type are not catered for within the AS 1684 standard series and require design by a suitably qualified structural engineer. A number of tie-down straps were fixed to the roof-frame in places not immediately above the cavity (see Figure 10). In this situation, the loose straps are not able to provide a vertical resistance force at that point. Unless the roof is restrained at other places it is free to lift and/or move sideways until the strap is entirely vertical and taut.

Figure 10. Photograph showing poor tie down strap installation (strap being fixed down the roof line)

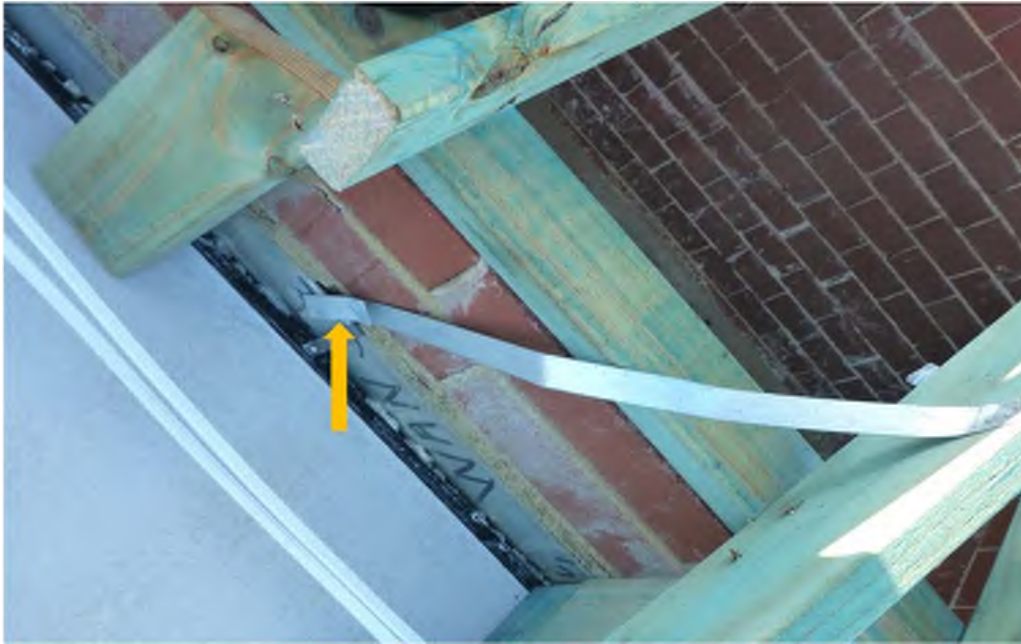
Figure 11. Photograph showing tie-down strap looped through a slot in a lintel

- A strap connected to a lintel (when the lintel is supporting a limited weight of masonry) may not be able to resist the design wind uplift forces (see Figure 11).

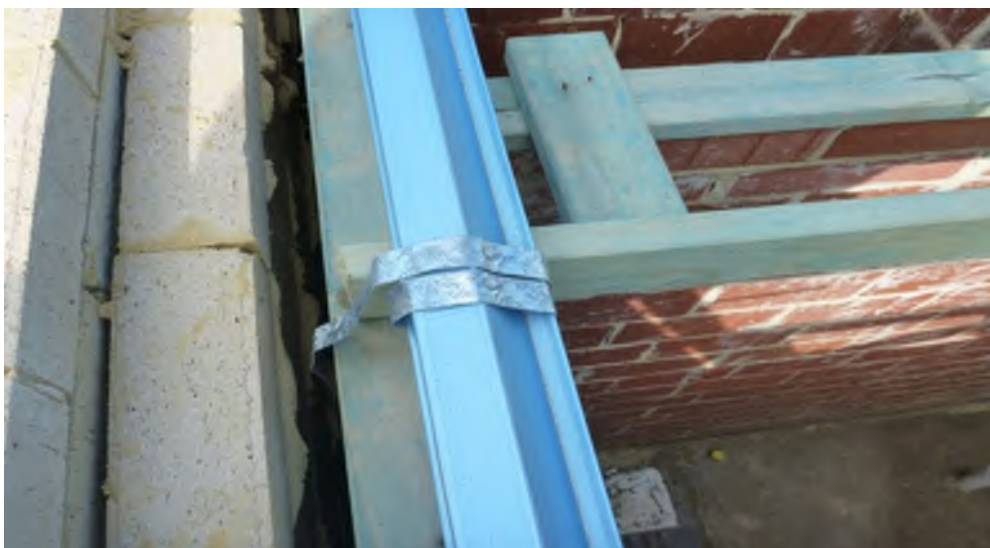
Figure 12. Photograph showing tie-down wrapped around metal batten (Note: the tie down is loose)

- Straps installed but not fixed-off to the roof frame by the carpenter.
- Fixing to metal battens where the batten may crush or distort when loaded during peak design wind events (see Figure 12).
- Carpenters commented that when they sought to tension the strap prior to fixing it to the roof frame on occasion the strap pulled out of the masonry. This indicates that in some cases the straps may not be installed within the brickwork to adequately resist the uplift loads.
- Figure 13 indicates a typical example of poor workmanship observed where the tie-down was not pulled tight and has an incorrect nail type with no corrosion rating. This strap is also below the requirements for minimum size and galvanised coating thickness.

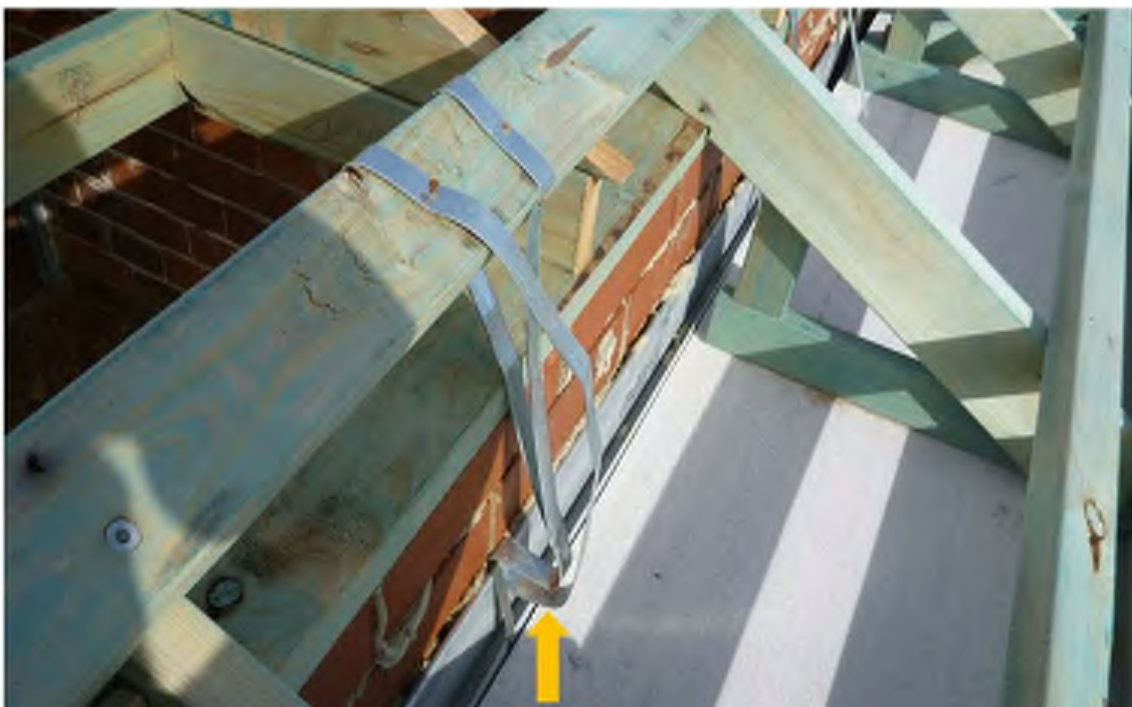
Figure 13. Photograph showing poor installation of tie-down straps

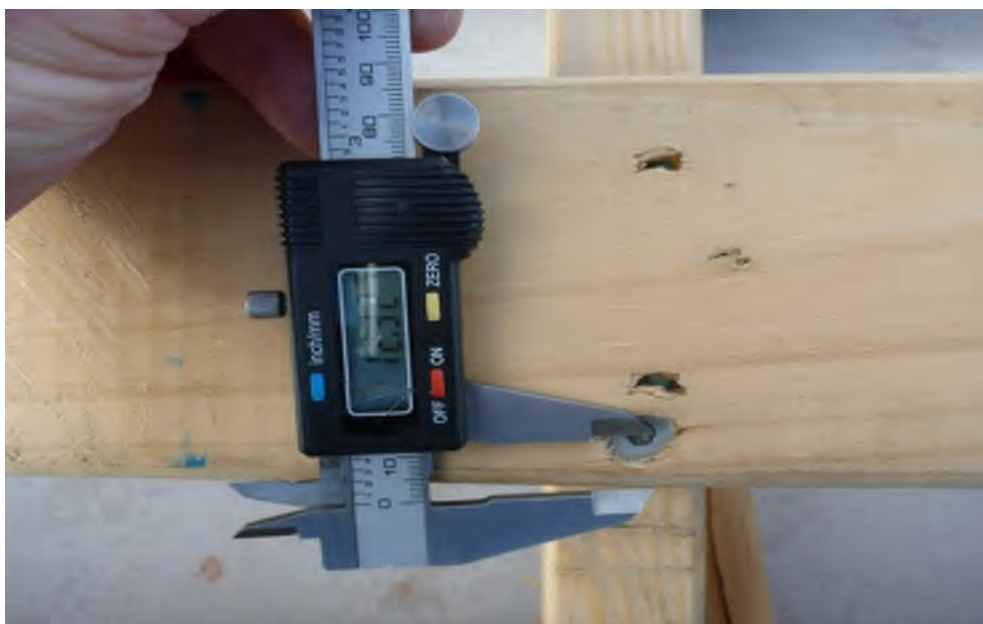
- AS 1720.1: 2010, Section 4.3, requires a screw fixing to be located 5 times the shank diameter from the edge of the timber. AS 1684.2, Table 9.25, where a single screw is required, shows the fixing in the centre of the batten. Roof carpenters should install the screw as close to the centre of the batten as possible.
- Figure 15 (below) shows a screw fixed within 12 mm of the batten edge compared to the standard requirement of a minimum edge distance of approximately 26 mm.

Figure 15. Photograph showing a batten non-compliant screw close to the edge of the batten

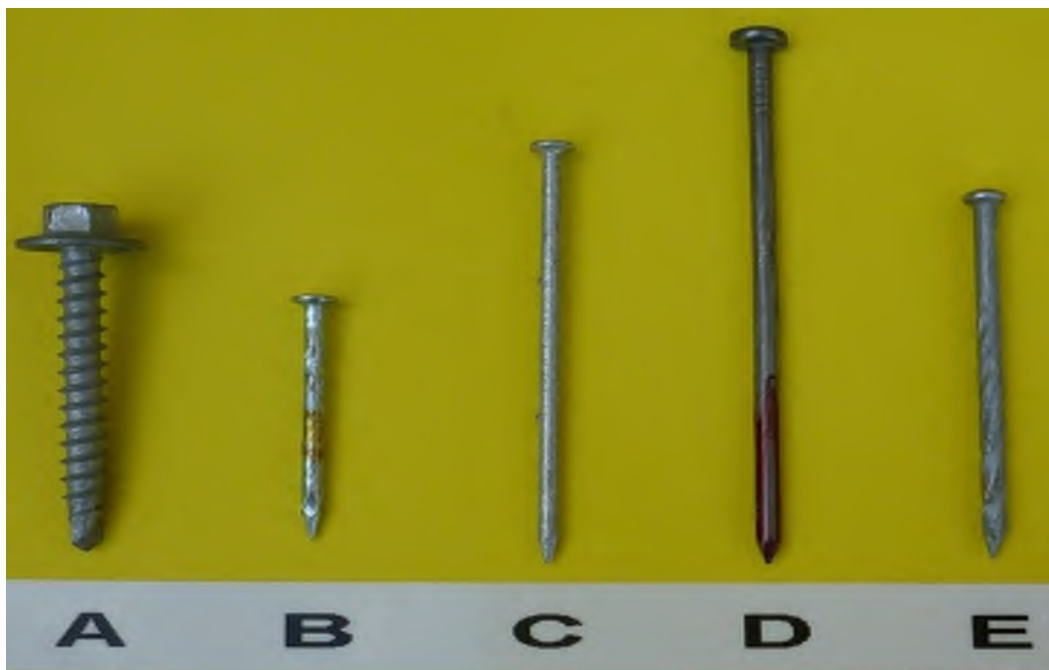
- A variety of connectors used to attach metal battens to the rafters were observed including hex-head screws and a variety of nails from 32 mm to 75 mm long – Figure 16 (A) represents a manufacturer's recommended screw for fixing metal battens and Figure 16 (C & D) were the most frequently used nail fixings identified in the audit.

Figure 16. Typical examples of fixing of metal battens observed

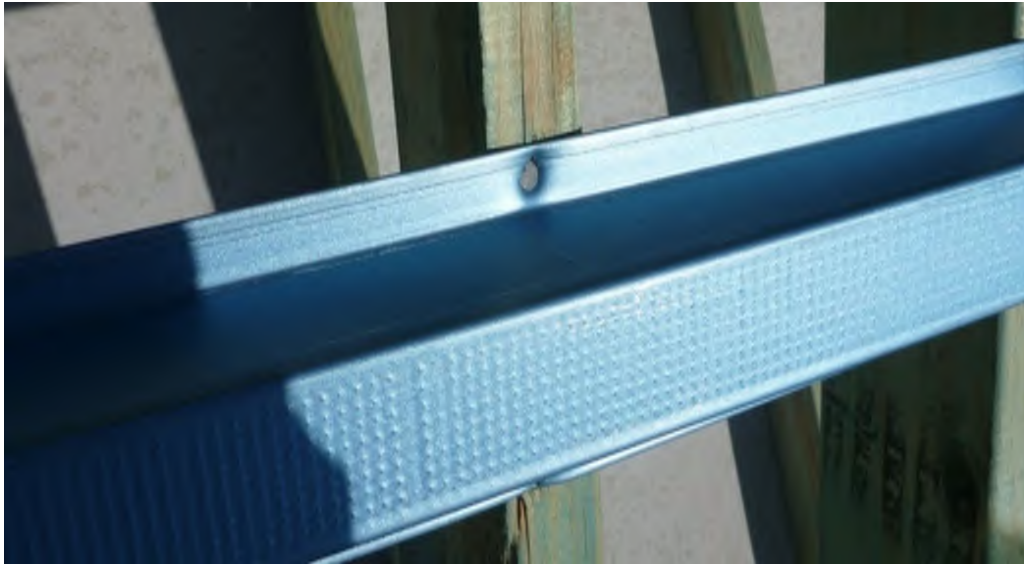
- Often 75 mm roof framing nails were observed over-driven into the metal batten, which may weaken the batten rafter connection and make the 0.55mm thick batten more susceptible to pull-through failure (see Figure 18 for a typical example of an over-driven nail fixing on metal battens).

Figure 18. Photograph showing a 75mm x 3.06mm nail over driven when used to fix a metal batten

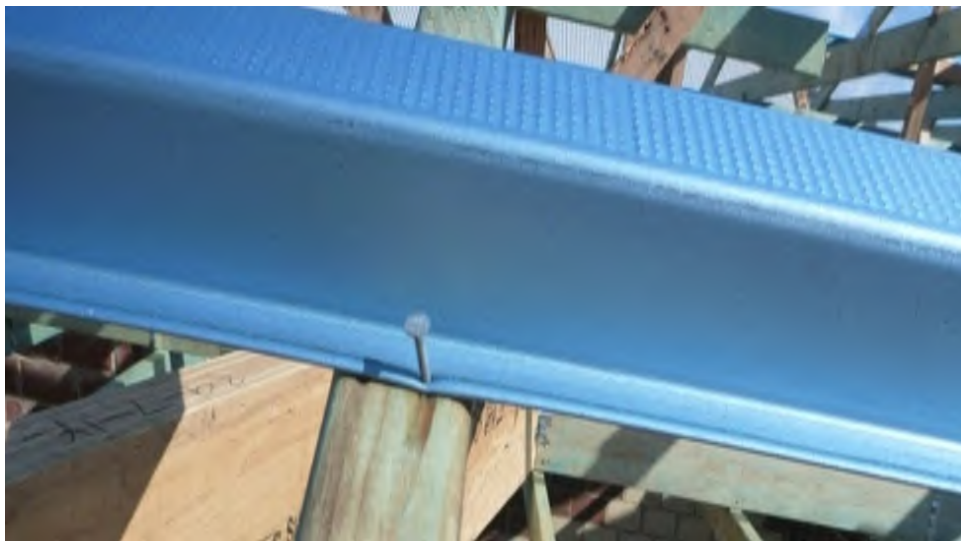
- In some roofs, more often when fixed with the 57 mm long x 2.6 mm diameter shank, the nails are under-driven – ie sitting up above the face of the metal batten and in some places observed by as much as 10 mm. Where this occurred it was often commonly found throughout the whole roof – eg see Figure 19 for typical examples of under-driven nails on metal battens observed during the general inspection.

Figure 19. Photograph showing a typical under driven nail fixing a metal batten around this roof

- Under-driving the nail is undesirable as less of the nail is embedded into the receiving rafter. The reduced nail penetration may give lower withdrawal capacity due to nail strength being a function of embedment depth.
- No evidence of over-driving or under-driving (or damage and deformation of the metal batten) was observed when the metal battens had been fixed with screws.

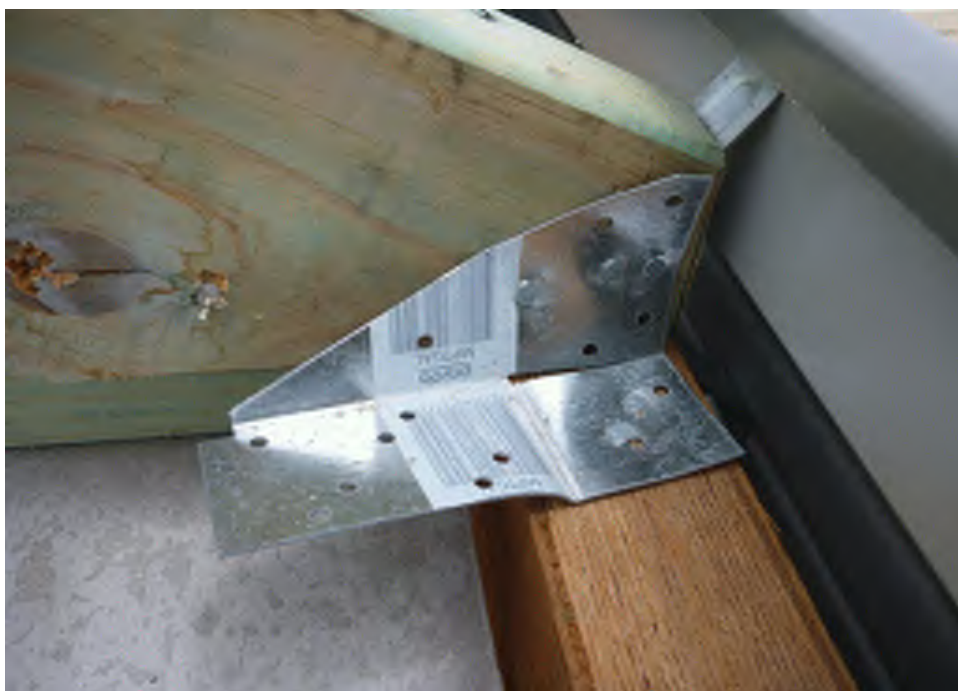
- Metal connectors were often observed laid on their side and in some cases nailed with as little as one nail per face (see Figure 20) compared with AS 1684.2 Table 9.21 (b) which shows four nails to each end.
- Failing to install metal connectors in accordance with the standard (or the manufacturing recommendations) may reduce connector capacity to resist wind uplift force.

Figure 20. Photograph showing a poorly installed metal connector making the connection between an alfresco beam and rafter

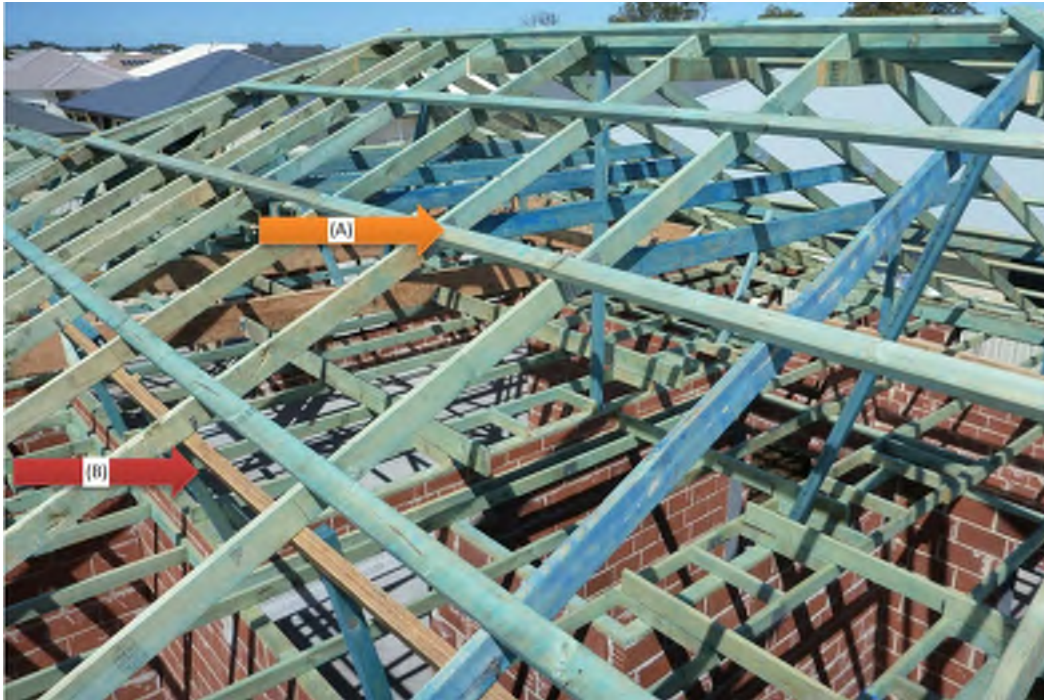
- In Figure 23 below the orange arrow (A) indicates location of collar ties compared to the red arrow (B) where the underpurlin is located.
- Collar ties should be located immediately above underpurlins as outlined in Figure 24 below.
- Figure 24(A) shows the standard method of fixing collar ties when two underpurlins are necessary.
- Figure 24(B) shows the standard method of fixing scissor collar ties when two underpurlins are necessary.

Figure 23. Photograph showing non-compliant collar tie installation

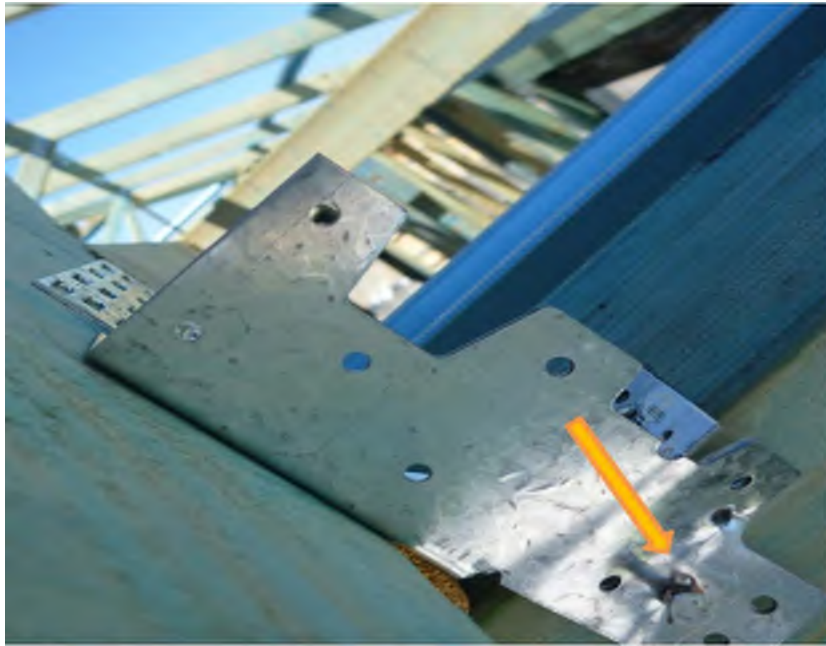
- Insufficient nails per metal connector. In some cases only 25% of the nails required by the standards were present (see Figure 25 as an example of one nail used where four nails per tab are normally required).
- Incorrect installation of metal connectors – ie installed horizontally instead of vertically.
- Incorrect support of the truss over the internal framework – ie blocking between the bottom chord of the truss and the internal top plate at places where the truss is not designed to be blocked.

*Figure 25. Rafter top plate connection with only one horizontal nail into the top plate tab
(Manufacturer recommends 4 nails)*

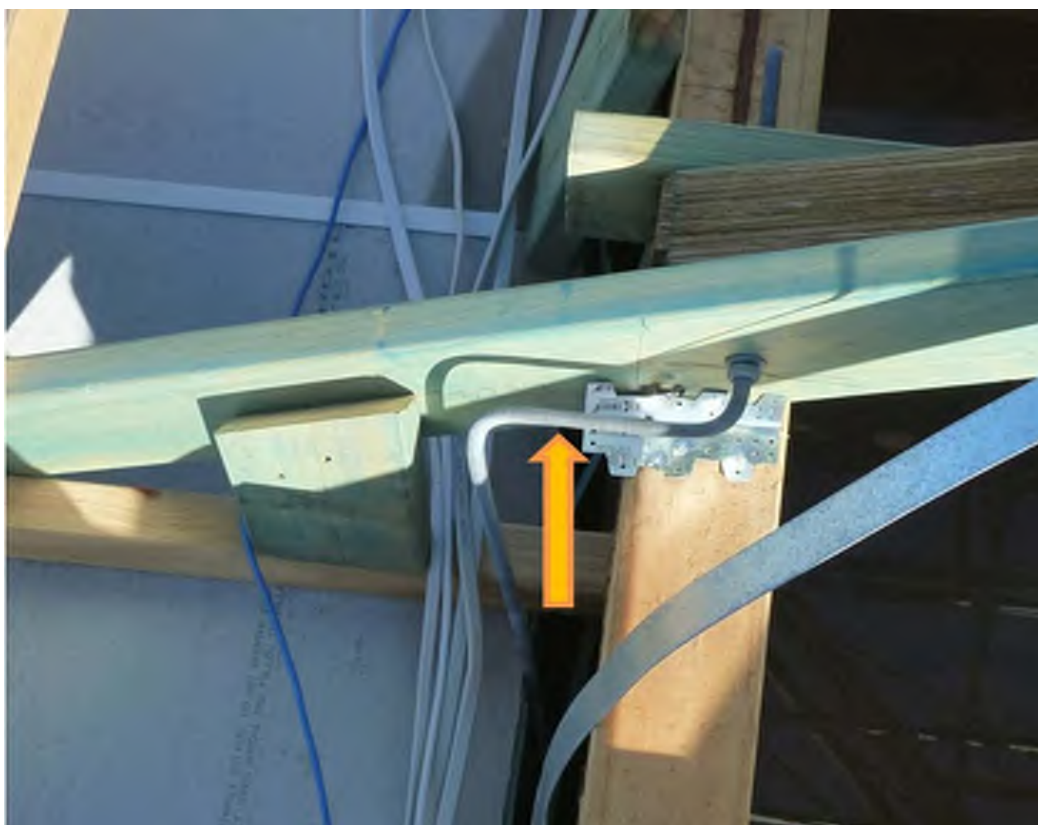
- Figure 26 shows a tie down rod bent to make the connection the beam which is unlikely to provide an acceptable tie-down at high design wind speeds.

Figure 26. Photograph showing a tie down rod bent to make the connection to the beam

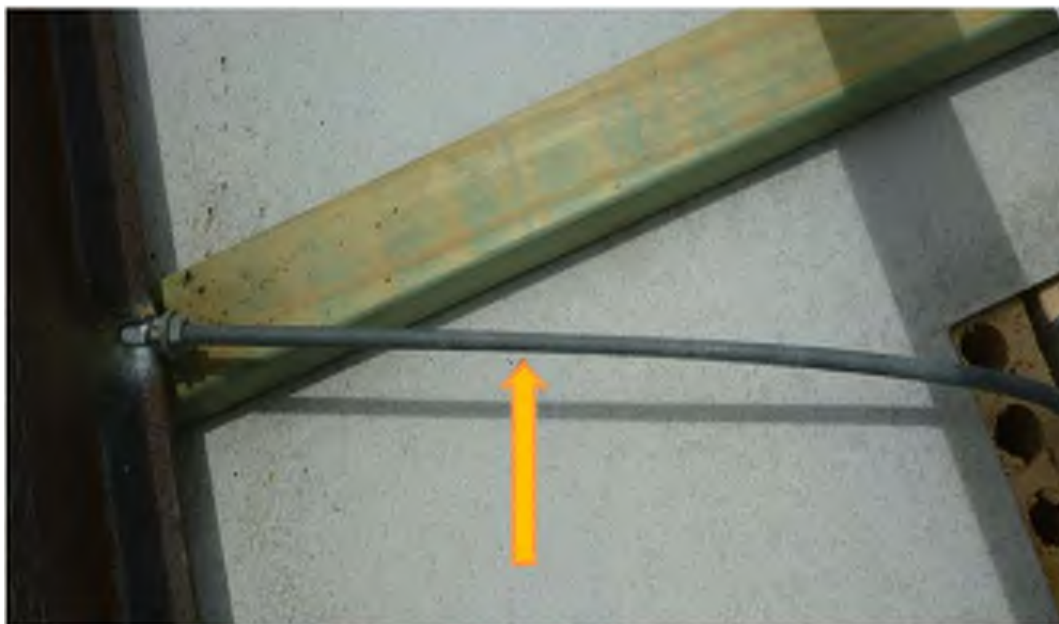
- A number of inspected roofs did have provision for the steel beams to be tied down, however, there were some very poor techniques used to attach the beam to the tie-down.
- Often the tie-down rod was located in a position in the masonry that required it to be bent at excessive angles in order to connect with the beam – eg see Figure 27 where a tie-down rod is bent and pulled across the roof horizontally to be fixed to the steel beam some distance from the location of the rod in the masonry.

Figure 27. Photograph shows poor installation of a bent tie down rod

- In some instances, where the rods were missing or poorly placed, a review of the plans indicated the poor installation resulted from failure of a bricklayer to install the rods in accordance with the plans.
- The BCA acceptable construction practise and deemed-to-satisfy provisions does not provide complete information regarding the tie-down requirements of steel beams in roofs.
