**General Inspection Report One: A general inspection
into metal roof construction in Western Australia**

April 2016

BUILDING COMMISSION GENERAL INSPECTION REPORT ONE (GIR1)

ROOF CONSTRUCTION: A general inspection report into the construction of sheet metal clad timber framed roofing in Perth metropolitan and South West regions

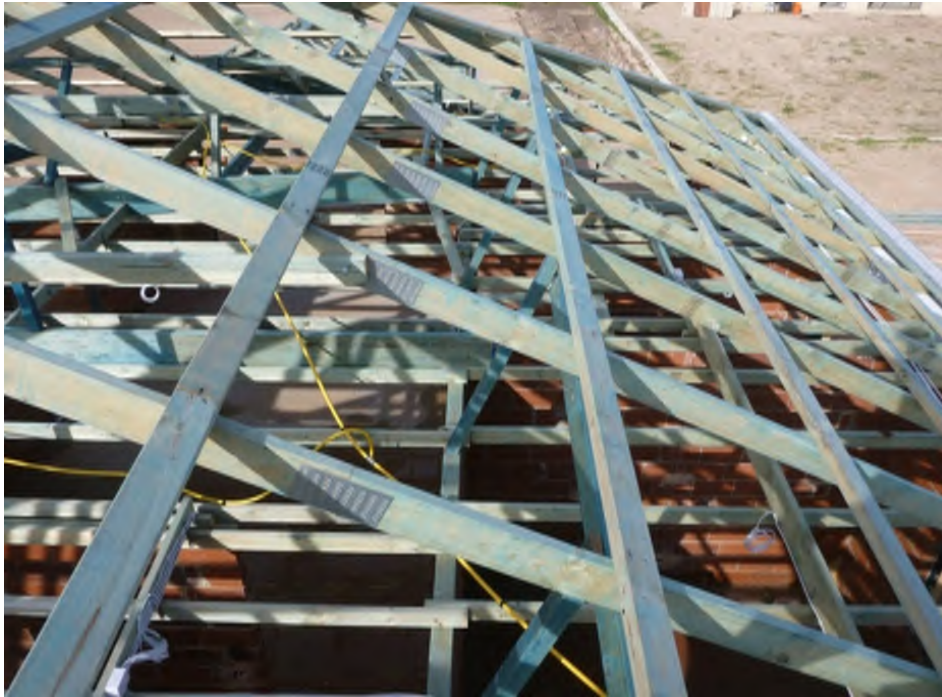
- Figure 14 shows a typical situation where timber battens are fixed to rafters.

Figure 14. Photograph showing typical timber battens fixed to rafters

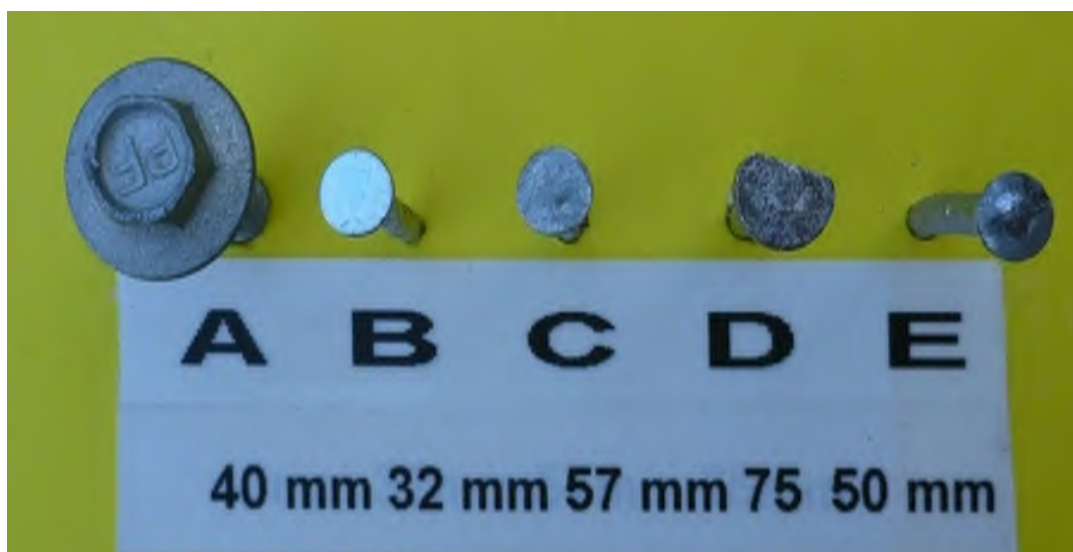
- Metal batten manufacturers generally recommend using two hex-head screws per batten rafter connection – Figure 17 (A) is a 15 mm diameter head (as recommended by manufacturers). The commonly used nails have head diameters (B) – 5.5 mm; (C) – 5.6 mm; (D) – 5.5 mm x 7 mm; and (E) – 5.4 mm head.

Figure 17. A comparison in the size of the fixing heads between the screw fixings

- A large percentage of the approved plans nominated a 57 mm long x 2.6 mm diameter nail that typically has a head diameter of approximately 5.6 mm.
- Nails with smaller head sizes than the batten manufacturers' recommended screws have a smaller surface area to resist pulling through the batten – eg allowing for the reduced shank area, the 15 mm screw has a cross-sectional area of approximately 146 mm², compared to a 5.5 mm diameter headed nail having an area of approximately 19 mm².

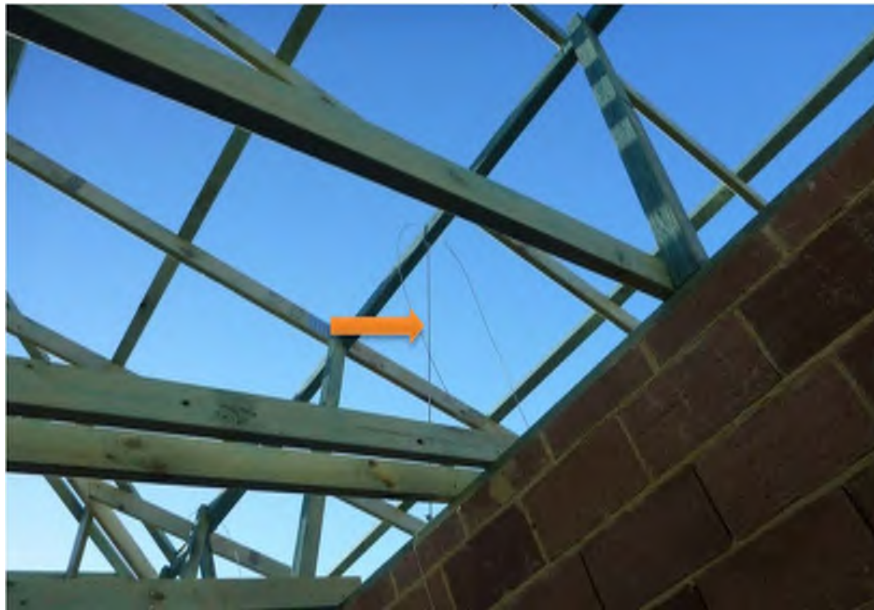
- Some builders use stainless steel wire looped above beams or underpurlins, taken down the interior masonry wall and looped through (or bolted to) the lower courses of masonry to create this chain effect and use the weight of the internal brickwork – eg see Figure 21 and Figure 22.

Figure 21. Photograph showing an internal hold-down wire fixed over underpurlin

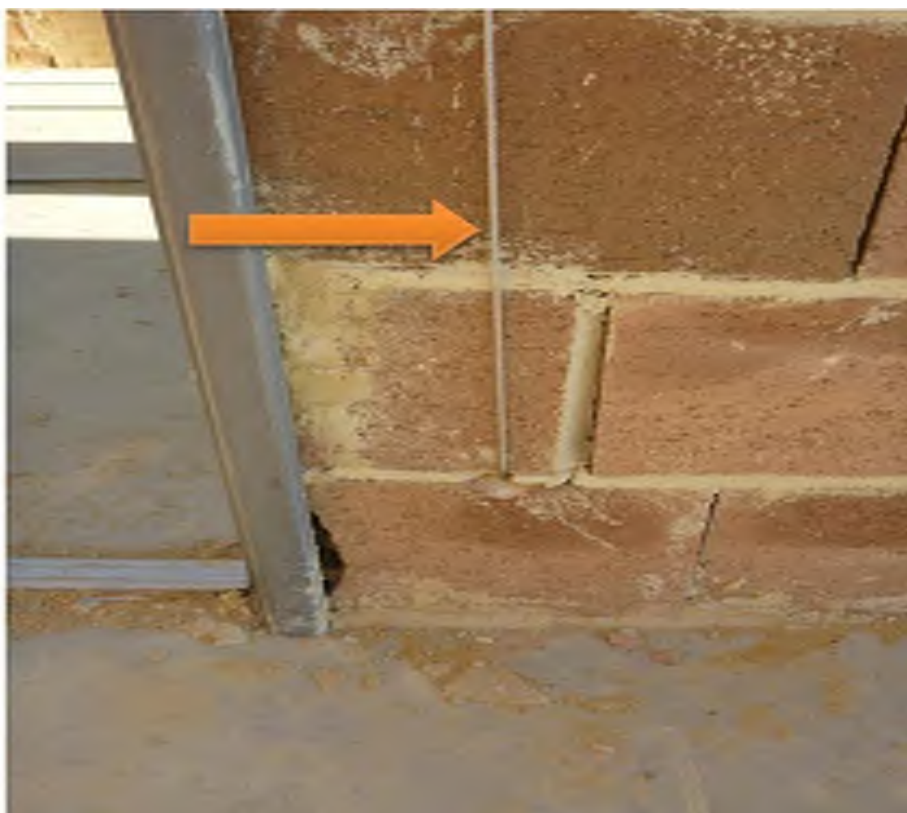
Figure 22. Photograph showing a hold-down wire attached into the internal masonry

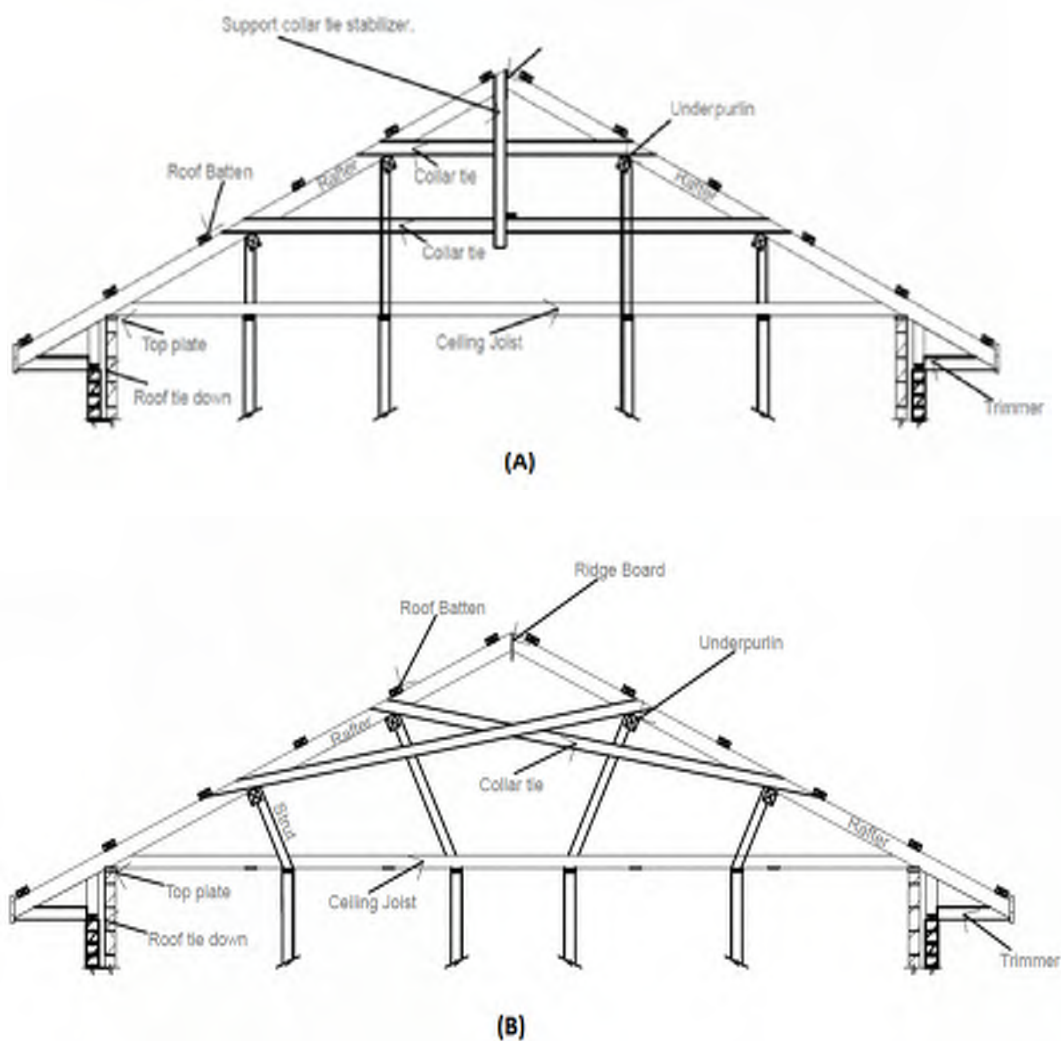
Figure 24. Requirements for collar ties as per AS 1684.2-2010

- In Figure 23 below the orange arrow (A) indicates location of collar ties compared to the red arrow (B) where the underpurlin is located.
- Collar ties should be located immediately above underpurlins as outlined in Figure 24 below.
- Figure 24(A) shows the standard method of fixing collar ties when two underpurlins are necessary.
- Figure 24(B) shows the standard method of fixing scissor collar ties when two underpurlins are necessary.
